# CoreAlign Redesign Project Summary

**THOUGHT BOMB DESIGN**

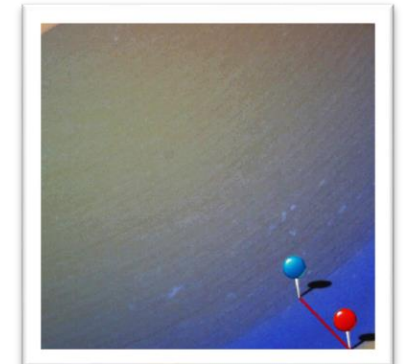
Inspection of latex tube layers

- The primary issue of concern was that the latex tubing, which is central to the equipment's use, was failing earlier than predicted
- Getting useful data to estimate tubing life was difficult. No two users are the same and exercise routines vary wildly
- Latex is a natural product with inherent variability. It also decays fairly rapidly with time, heat, and moisture

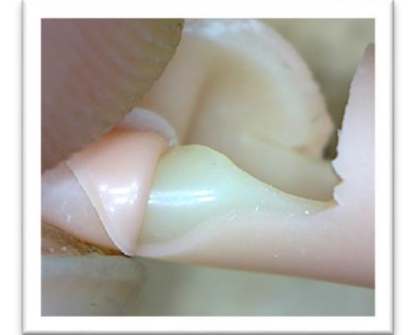
Inspection of latex tube delamination

- A cycle testing machine was designed and built to provide useful data to gauge tube life when changing specific variables
- Multiple vendors, tube sizes, and attachment methods were tested
- After extensive testing and detailed failure analysis, new failure modes were found and the ideal extension ratio for the best tubing was found
- The tubing life was increased, the carts were made longer, cart travel was added, assembly time was decreased, BOM cost was lowered, and the weight was kept the same

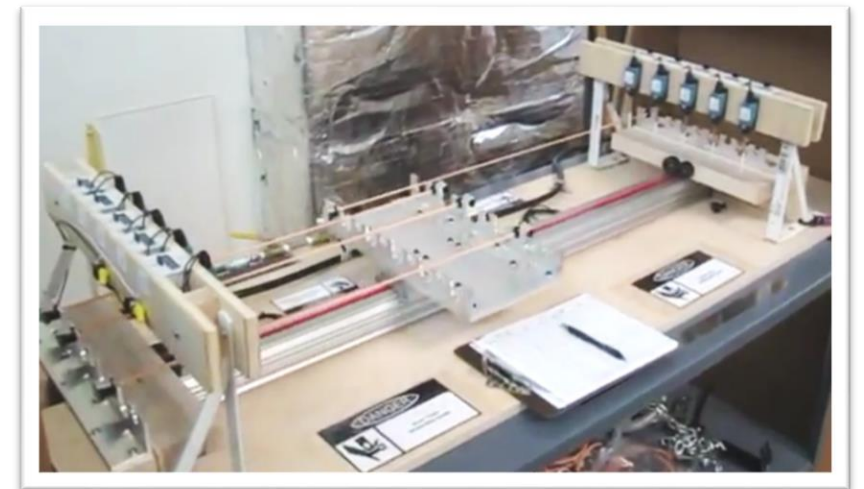
Cycle testing machine to test 10 tubes at once
